Kevlar[®] 49/Epoxy COPV Aging Evaluation

James K. Sutter, Jonathan L. Salem and John C. Thesken
NASA Glenn Research Center at Lewis Field

Aging Aircraft 2008

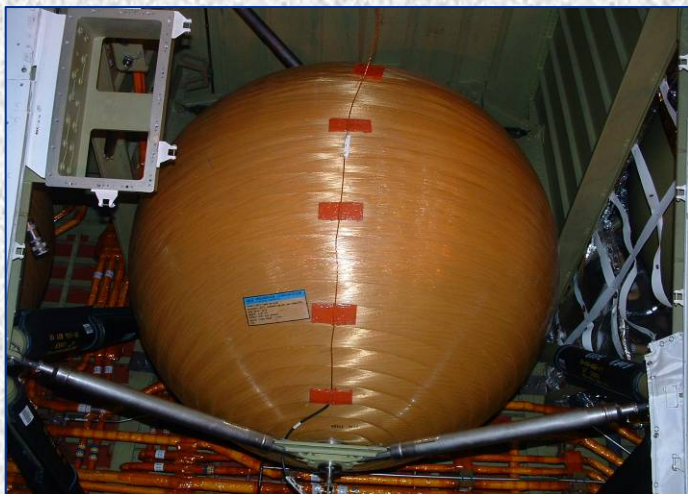
Orbiter Systems

1. Fore/Aft RCS Helium
2. ECLSS Nitrogen
3. ECLSS Oxygen
4. MPS Helium
5. OMS Helium

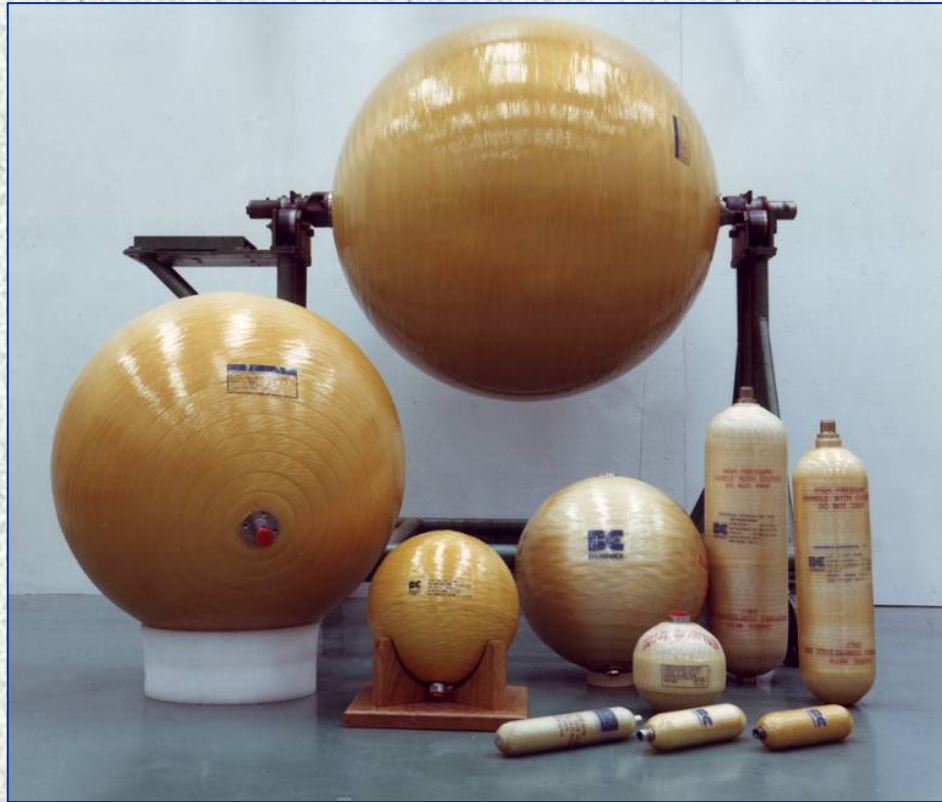
- Liner
 - Pressure-tight
 - Metal or plastic
 - Permeation barrier
 - Leak-before-burst (LBB)
 - Failure can be catastrophic

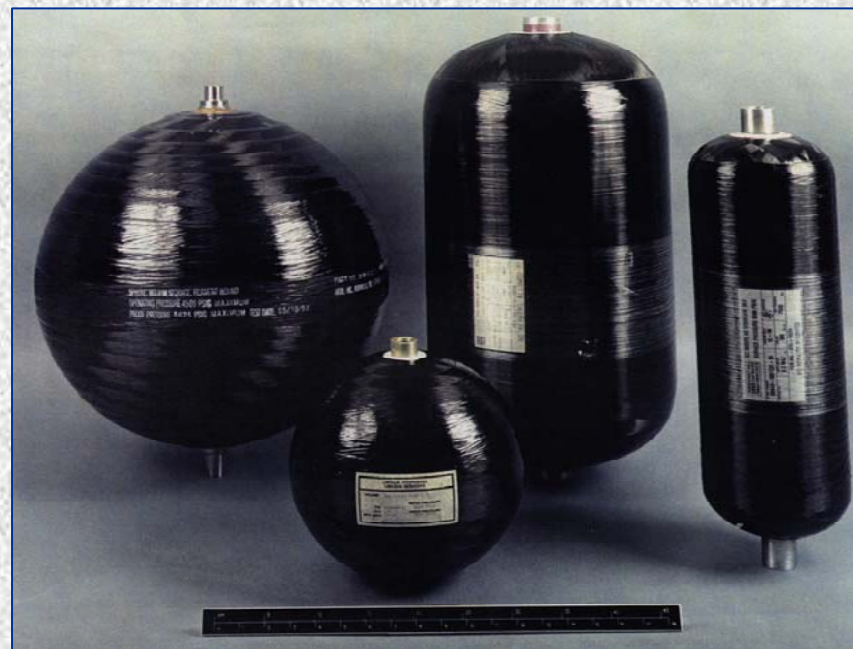
- Composite overwrap
 - Fiber & resin
 - E- or S-glass, Kevlar[®] 49, Carbon, Spectra
 - Epoxy matrix
 - Encapsulates liner
 - Provide strength
 - Failures result in catastrophic high energy releases

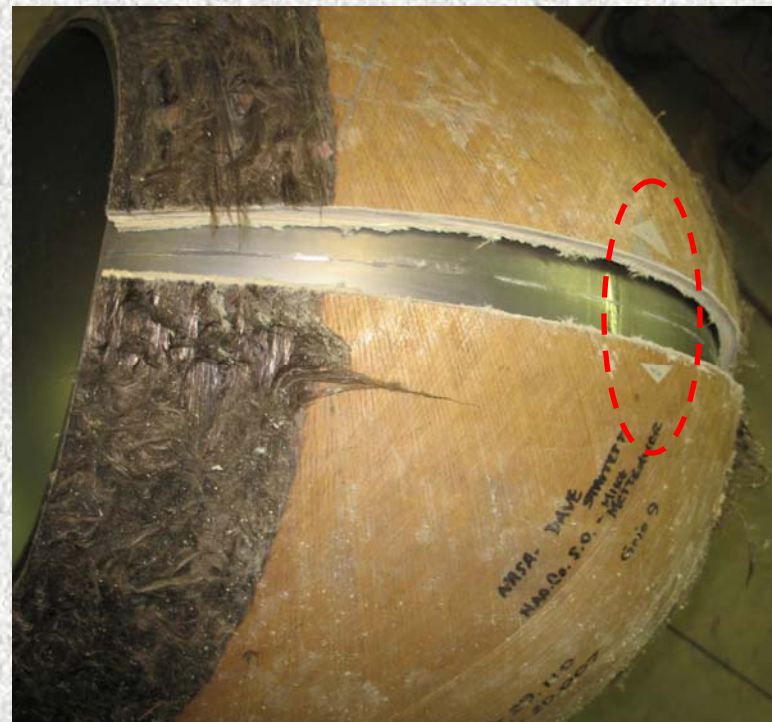
S/N 029 Cross-section
- Ti 6/4 Liner
- Composite Overwrap

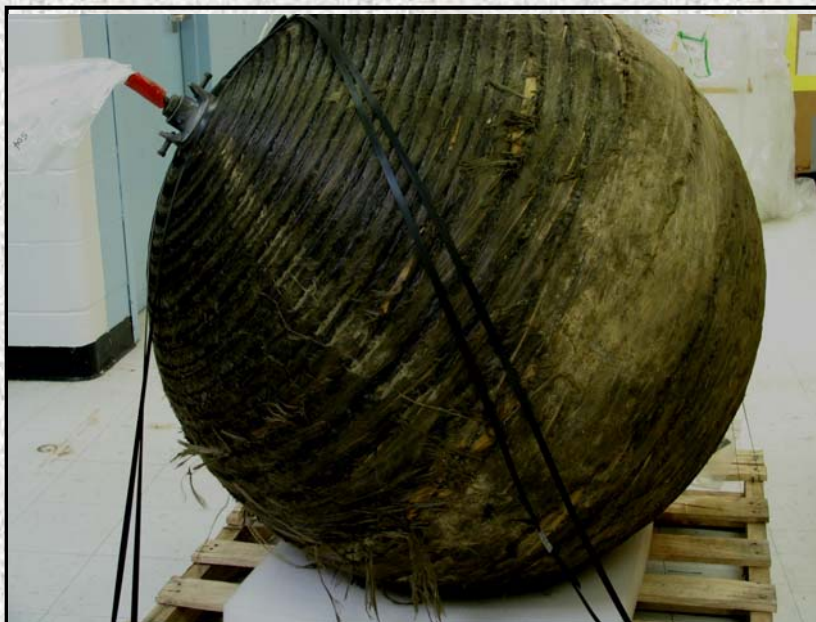
- S/N 029 Columbia OV-102 COPV ~ 25 yrs old
 - Survived reentry
 - Composite Interior Provided Good Samples
 - Manufactured by Brunswick Composites (GD)

**Columbia OV-102 COPV (40 inch)
Model S/N 029 Damaged Outer Shell**

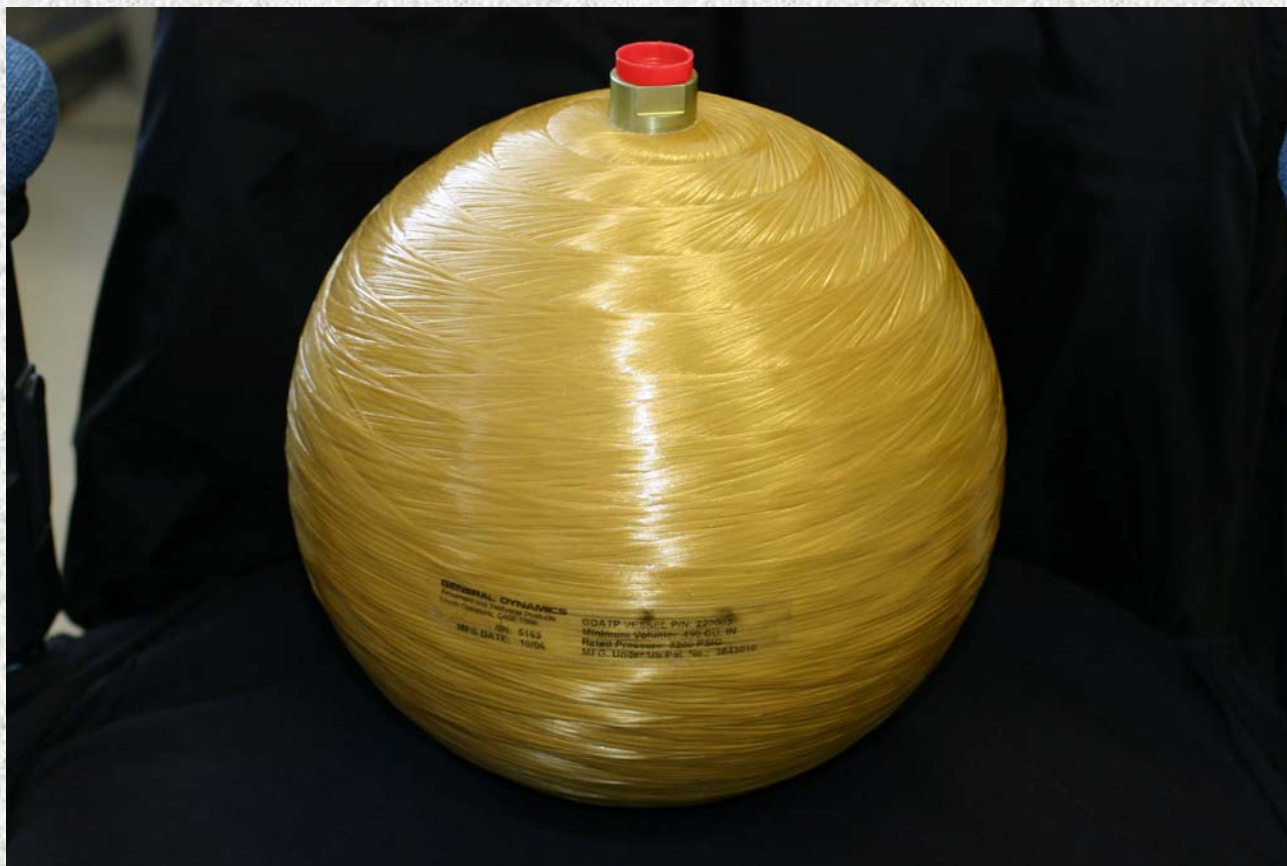
- New 10 inch Kevlar® 49/LRF-092 COPV (390 in³)
- Manufacturer is General Dynamics – Lincoln Composites
- Same fiber and epoxy as Orbiter COPV S/N 029 and 011
